**CALIFORNIA REGIONAL WATER QUALITY CONTROL BOARD - SAN DIEGO REGION
WATERSHED MANAGEMENT PROGRAM**

FACILITY INSPECTION REPORT

INSPECTION DATE: **January 12, 2005**

FACILITY: Morro Hills Villages
C,D,E,G

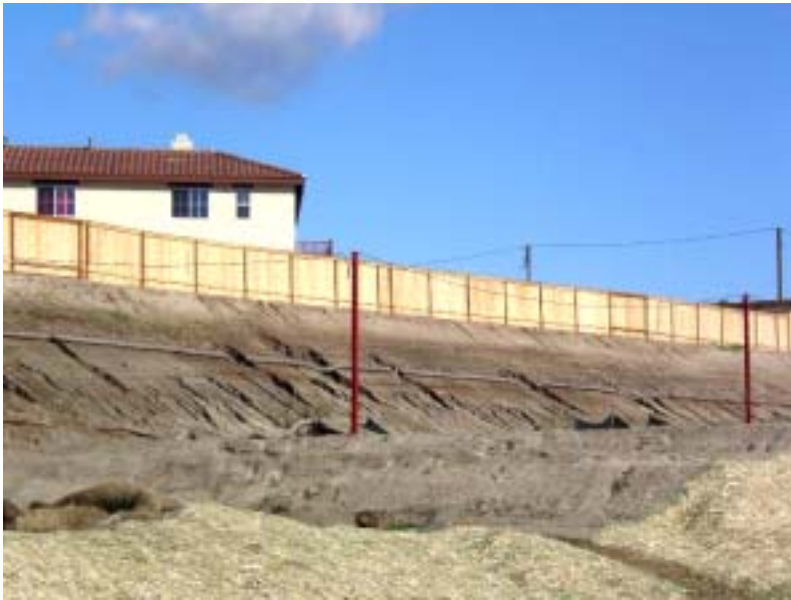
Finished slopes within Villages C & D are eroded due to inadequately maintained erosion control BMPs. Note some straw matting was utilized on small housing pad slopes.

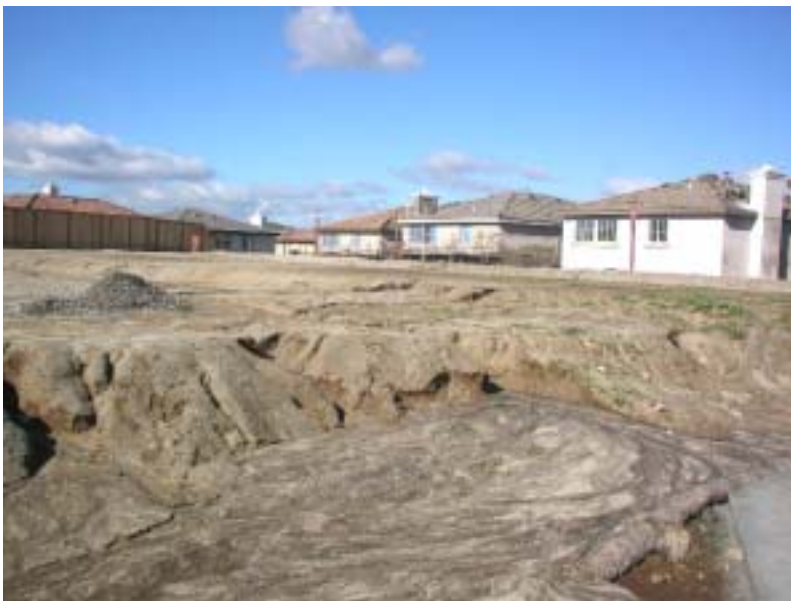
Finished housing pads are eroding. Developer needs to stabilize these flat areas that will be idle during the rainy season.

- Villages under Fieldstones NOI coverage to the east of Village G where housing is being built are in better condition, but there was evidence that finished housing pads are eroding. I suggested that flat disturbed areas which will be idle through the rainy season would benefit from some form of stabilization, and that spray erosion control might be an appropriate BMP.

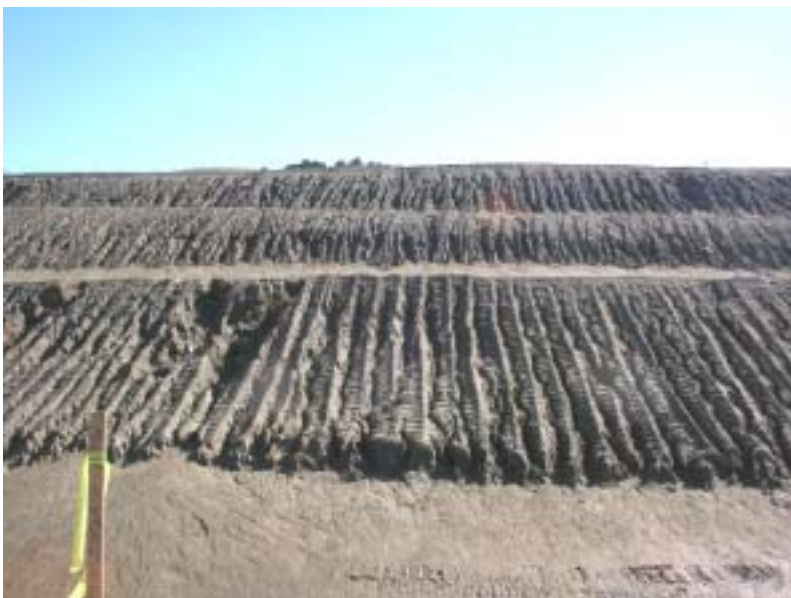
Slopes within Village G appear to not have any type of stabilization, and are suffering severe rill and gully erosion on a site wide basis.

- Sprayed erosion control had allegedly been in place on slopes prior to the large October Storms, but failed, and nothing was done to fix them after those rains, which has lead to the dismal condition of the site today.
-

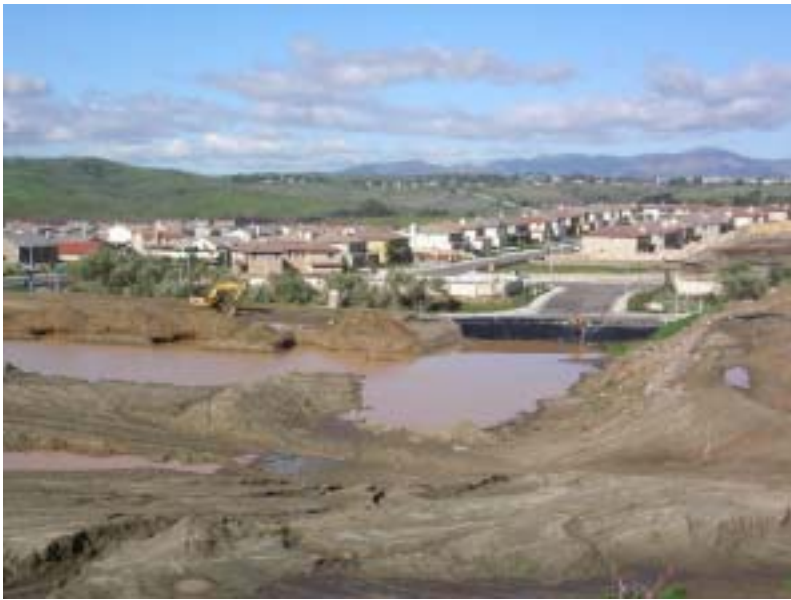
Plastic lined dirt berm has been constructed at site of previous pumping discharge to provide further capacity to collect runoff. But site is still discharging offsite to Vandergrift Blvd storm drain inlets.

- A berm was built up at the site of the 1/4/05 illicit discharge to add additio9nal capacity, however the area along Vandergrift Blvd. has failed causing discharge offsite. There is still a great deal of sediment laden water stored on-site.

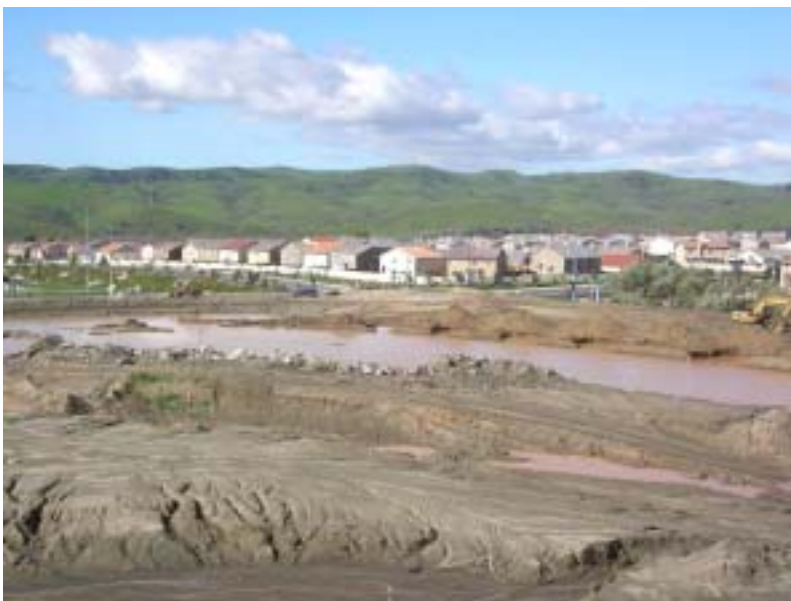
Village G still has a great deal of sediment laden water stored on-site after last significant storm event. Will need filtration to BAT standard prior to discharge, or needs to be spread out over site if soil is not too saturated. There is no outlet for these impoundments of water.

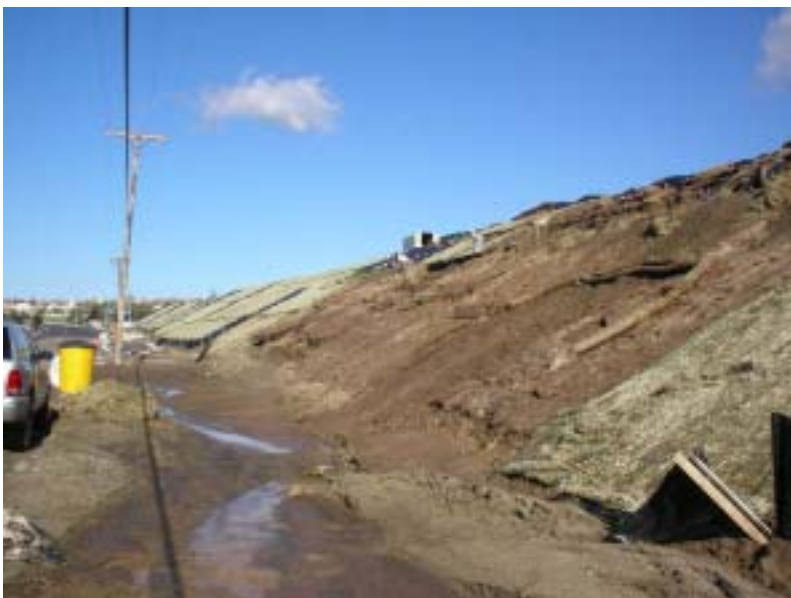
Straw Matting had been placed over slopes on Vandergrift Blvd. where they were not too eroded, some portions of slopes will need to be fixed prior to installation of erosion control.

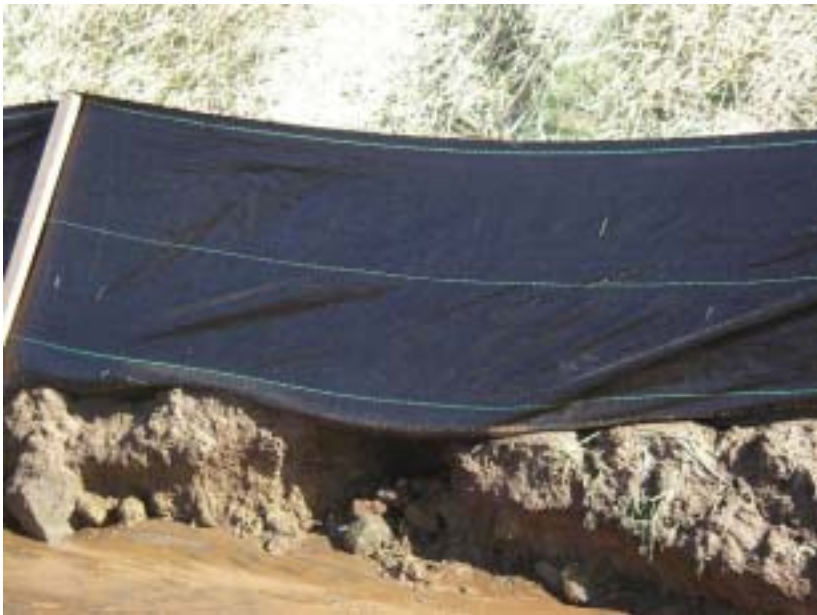
Silt fencing along Vandergrift Blvd. needs to be properly installed to prevent further discharge into City of Oceanside MS4.
